RE: Wetland letter report for Chester Industrial Park parcel  
Parcel: S/B/L 116-1-1.2  
Town of Chester  
Orange County, NY

# Chester NY SBL: 116-1-1.2

# WETLAND DETERMINATION DATA FORM - Northcentral and Northeast Region

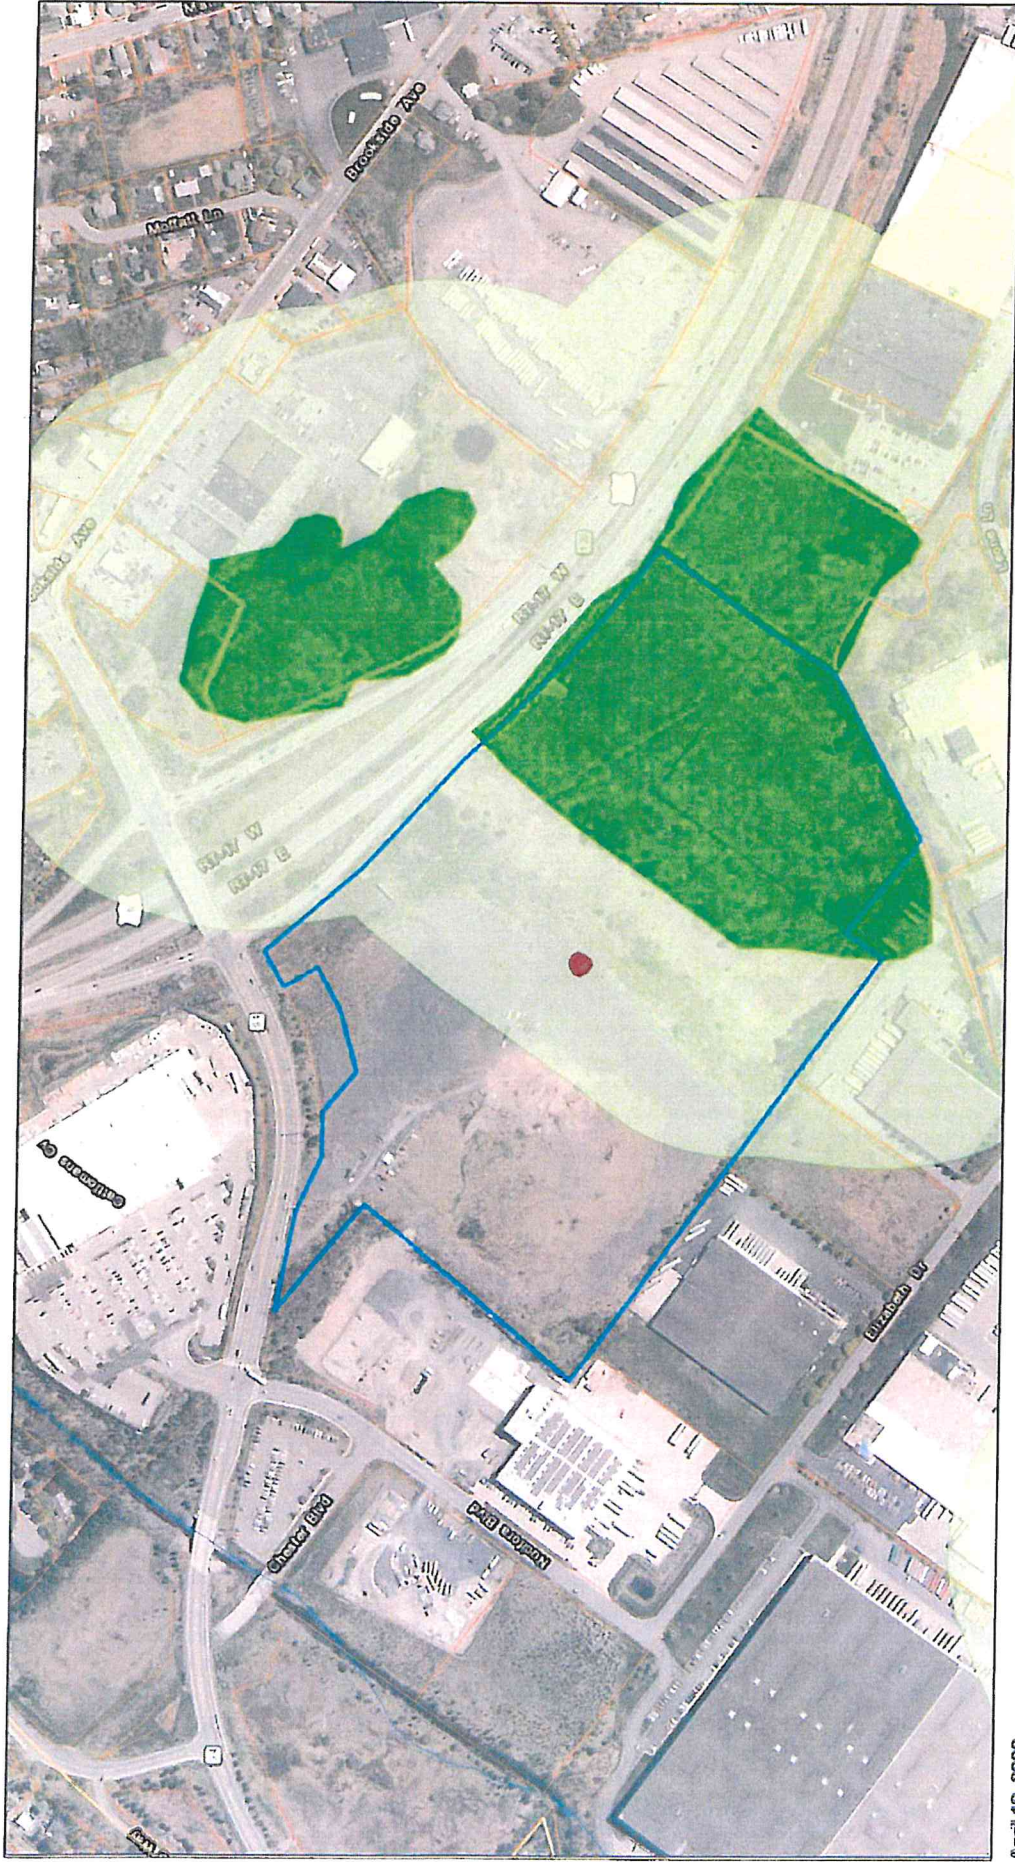
The online NYSDEC remote wetlands mapper resource shows a state regulated wetland is remotely mapped across the eastern portion of the property. This wetland (NYSDEC Freshwater Wetland WR-8) is shown on the attached NYSDEC Environmental Resource Mapper figure as being present on either side of Route 17, connected by culverts. As also depicted on the attached figure, all NYSDEC wetlands are bordered by a NYSDEC regulated 500-foot state checkzone<sup>1</sup>. An excavated portion of a stream that aligns with the boundary lines of several properties within the industrial park forms a border along the southeastern portion of this property. It is an un-protected (Class C) stream (NYSDEC Regulation No. 862-195) which, beyond Chester, drains into the Otter Kill, a tributary to Moodna Creek and ultimately to the Hudson River.

State Regulated Freshwater Wetlands
-

State Regulated 500' Wetland Checkzone

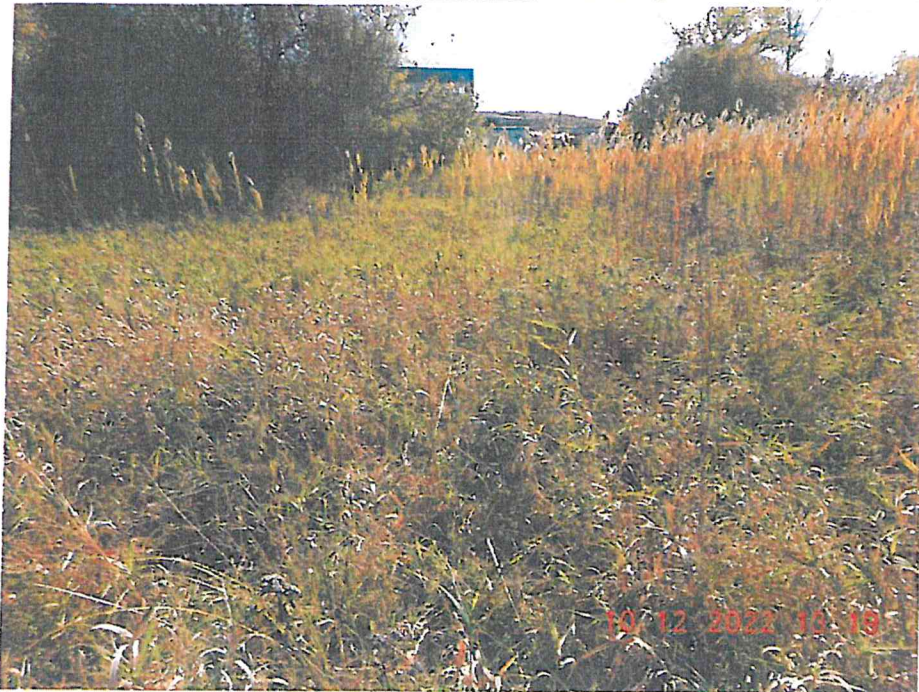
Photo File: **DSCN9298.JPG** Orientation: **South -facing**

Description: **Reed canarygrass field along phragmites stand.**

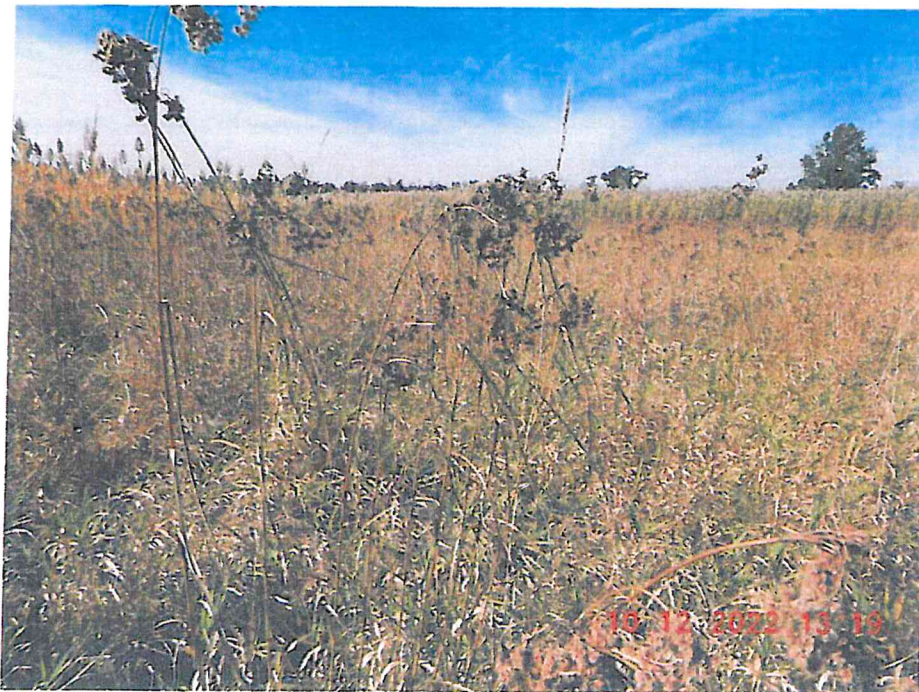
Photo File: **DSCN9299.JPG** Orientation: **North -facing**

Description: **Reed canarygrass field along phragmites stand.**

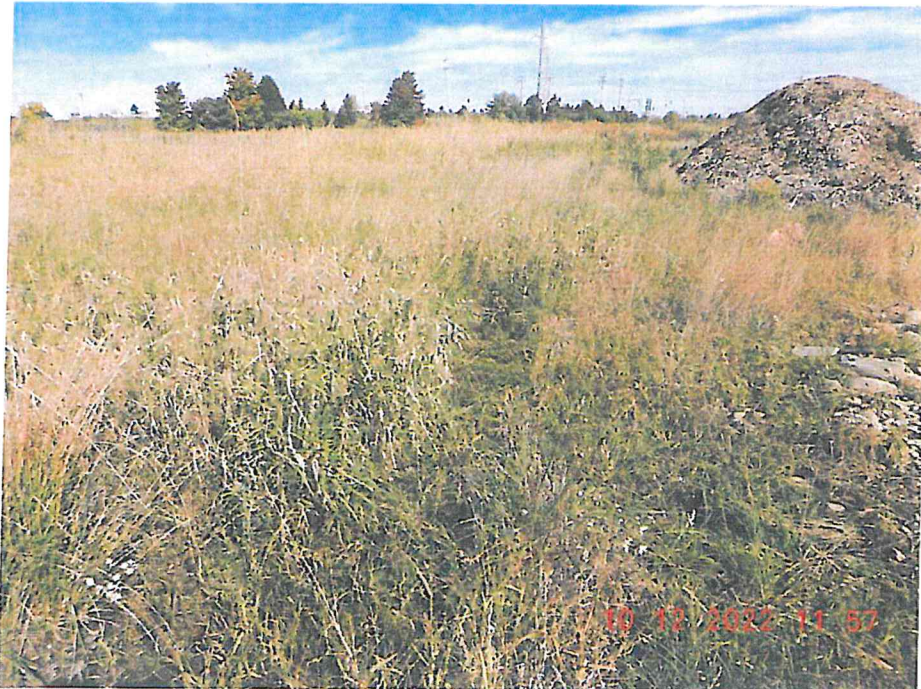
Photo File: **DSCN9281.JP**

Upland areas of the site are present primarily as areas of spread and leveled shale fragments of indeterminate depth to native soils.
